EnergySTEP1 Data Center Assessment Customer Report

XYZ Company Data Center 101

ES1 Sample Report

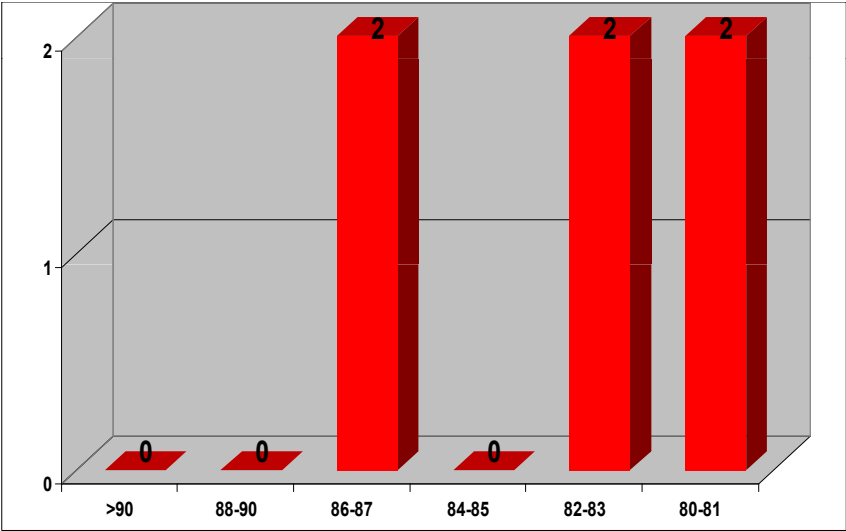
Rack Inlet Temperature exceeding ASHRAE TC9.9

Up to 25% of the racks have inlet temperatures exceeding ASHRAE TC 9.9 limits (80.6 deg F or 27 deg C).	Perform a more detailed assessment to determine root cause and corrective action.	Unknown without further analysis

- Six of the racks have air inlet temperatures exceeding ASHRAE TC9.9 recommended temperature of 80.6 deg F. The elevated temperatures may contribute to increased failure frequency of the rack equipment. Perform a more detailed analysis to determine root cause and corrective actions.

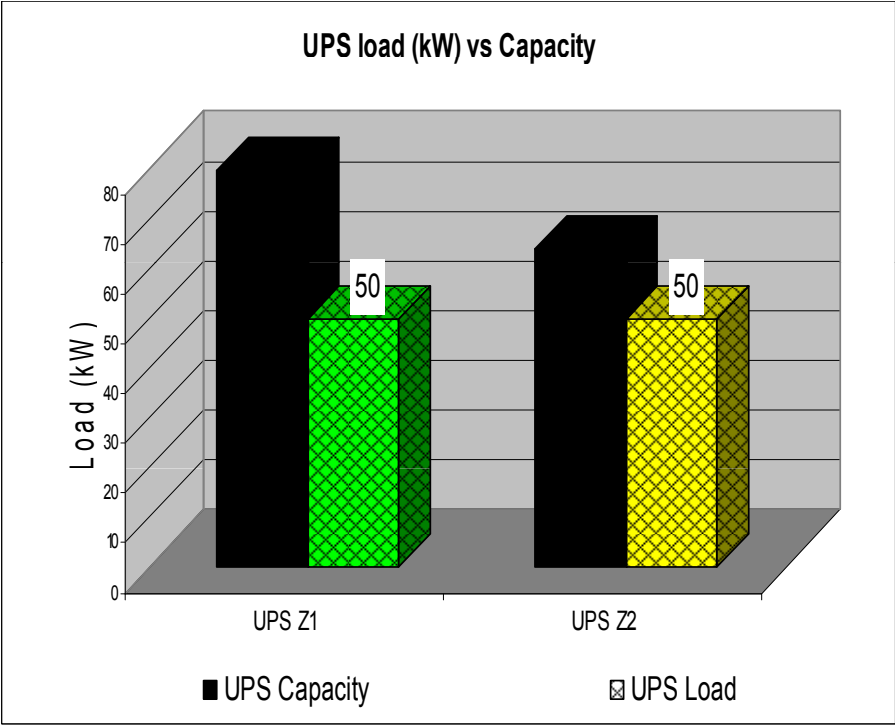
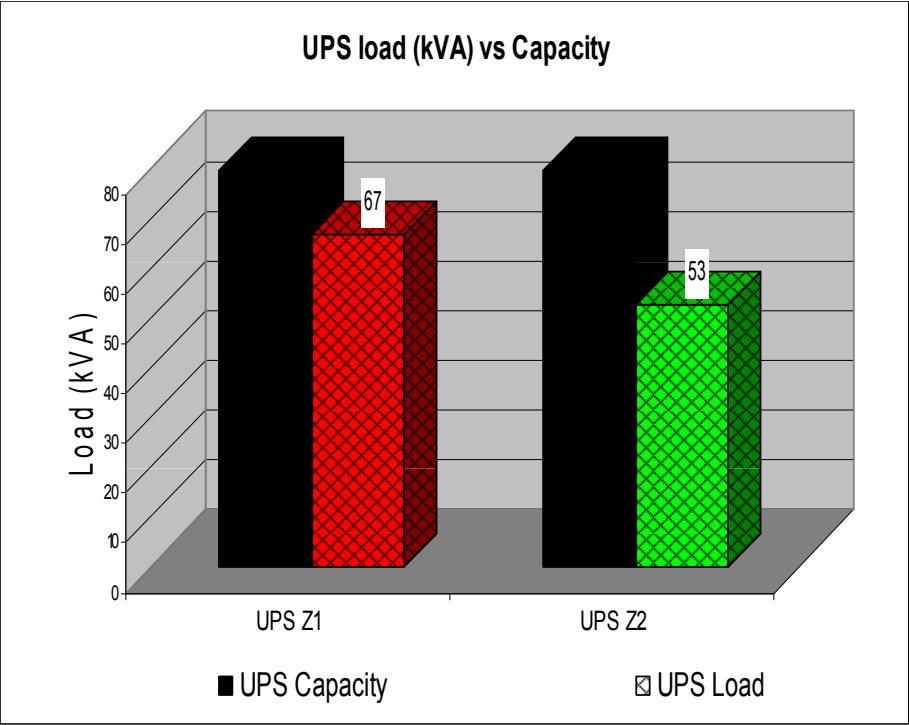
UPS Utilization Summary

UPS Z1 kVA load exceeds 80% of rated capacity. Transient power events may cause UPS to drop load.	Reduce the kVA load on the UPS to less than 80% of rated kVA load.	Not Applicable

- UPS load exceeds 80% capacity. Increase the capacity of the UPS or reduce the load.
- UPS load is between 70% and 80% capacity. Load is within industry best practices but future load growth is limited.
- UPS load is less than 70% capacity.

- UPS Z1 kVA load exceeds 80% of rated capacity. Transient power events may cause UPS to drop load. Reduce the load on the UPS or increase the capacity.
