EnergySTEP1 Data Center Assessment Customer Report

XYZ Company Data Center 101

ES1 Sample Report

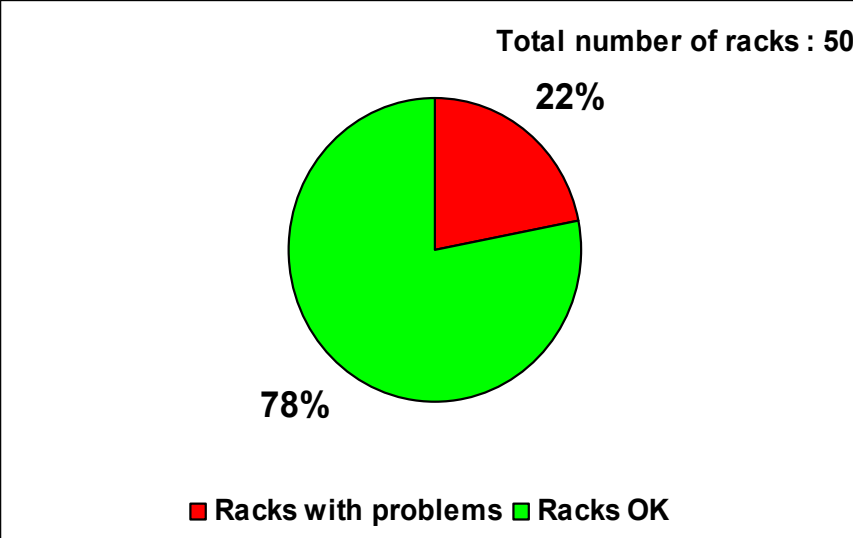
Overall Rack Status

Rack Summary

Rack Inlet Temperature exceeding ASHRAE TC9.9

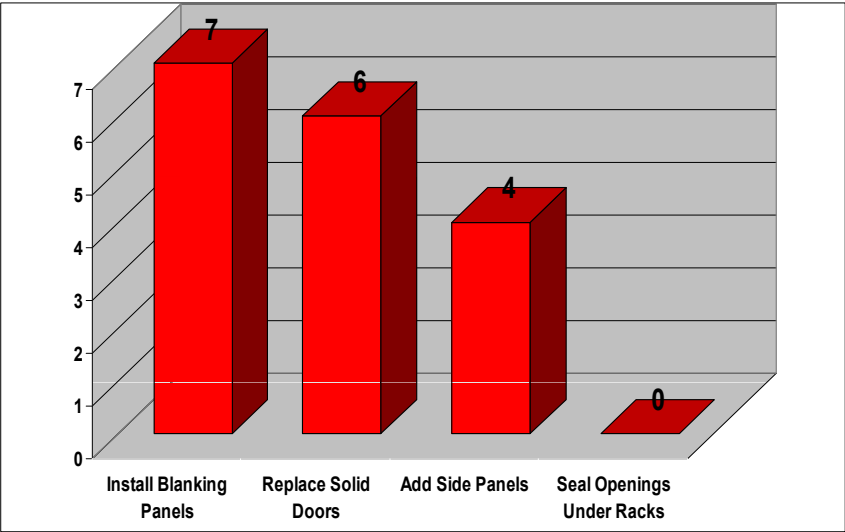
Rack Findings

Less than 25% of the racks have missing blanking panels.	Install blanking panels during next maintenance window to improve airflow efficiency.	<1%

Less than 25% of the racks are missing side panels.	Solid side panels improve air flow through the equipment and should be installed if possible.	1 - 2%

The raised floor is a supply plenum. There is significant air leakage under less than 25% of the racks.	Install wire brushes or grommets to seal cable penetrations under the rack and improve airflow efficiency.	1 - 2%

Up to 25% of the racks have inlet temperatures exceeding ASHRAE TC 9.9 limits (80.6 deg F or 27 deg C).	Perform a more detailed assessment to determine root cause and corrective action.	Unknown without further analysis
